### Integrated Approach of Geotechnical and Geophysical Investigations into Failed Segments of the Road Along Vwei (Mararaban Jama'a) - Mangu Road. North-Central Nigeria

Akushai Paul Meshach, Mamuda Isiaka, Retchen Raymond Ibrahim

Department of Minerals and Petroleum Resources Engineering, Plateau State Polytechnic, BarkinLadi

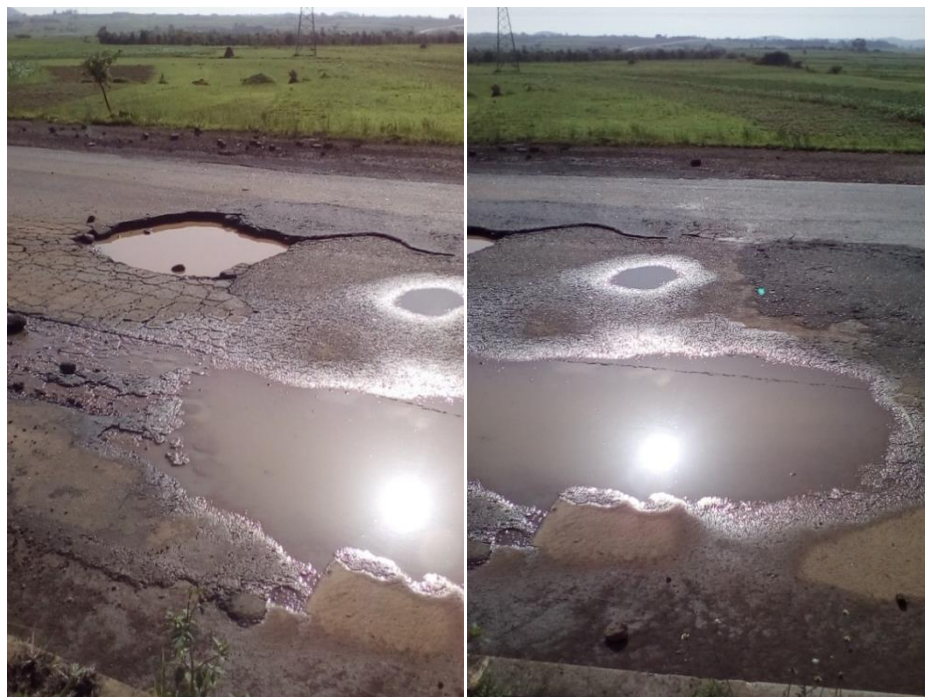
Plate 1: Failed segments of road at Bisichi Junction on the way to Mararaban Jama'a Plateau State.

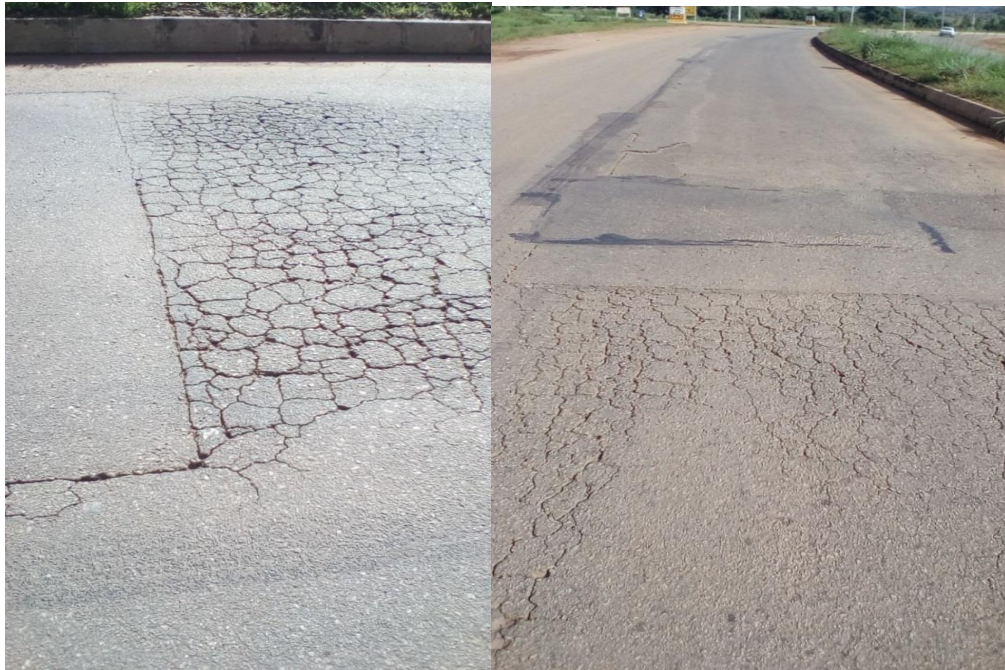
Plate 2: Failed segments of road at Kuru Jenta Junction Plateau State.

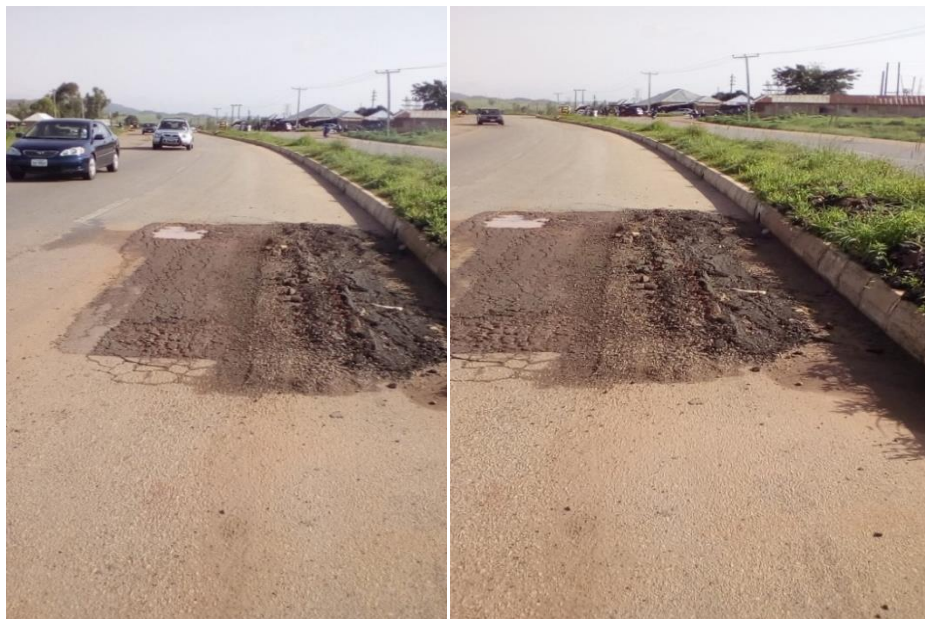
Plate 3: Failed segments of road just after Foron Junction enroute to the Polytechnic, Plateau State.

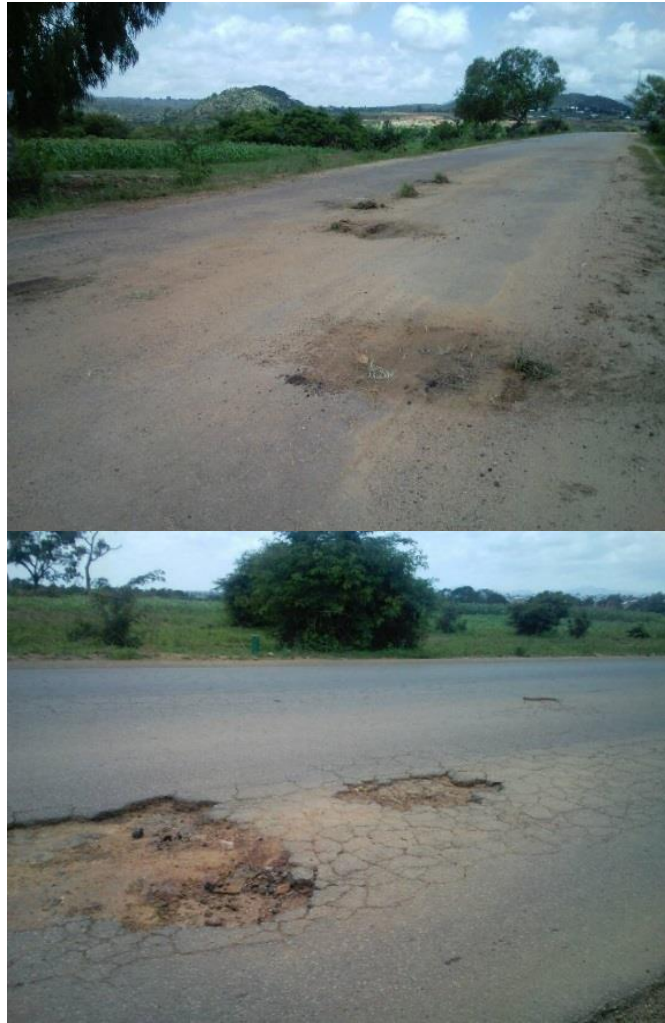
Plate 4: Failed segments of road at Dorowa, Plateau State.

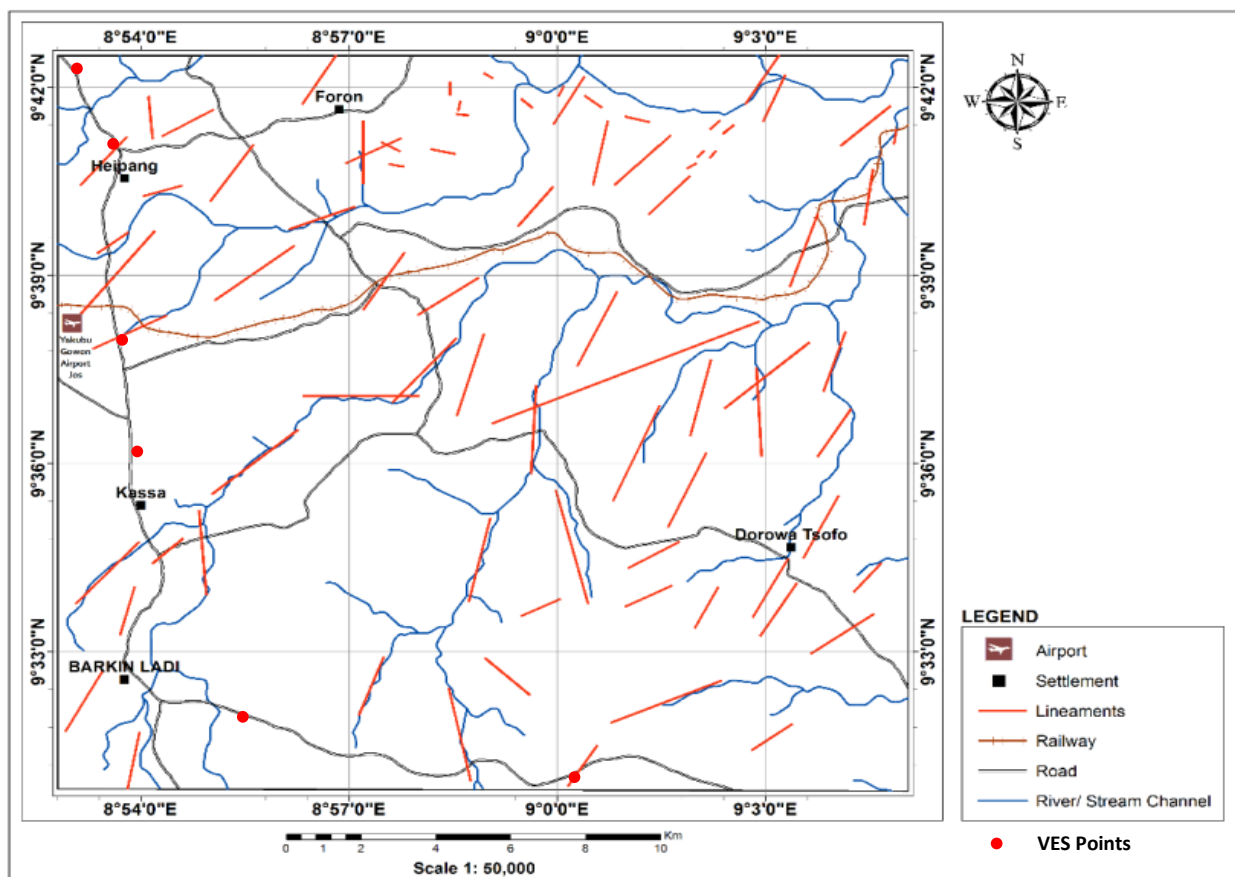
Figure 4: Lineament Map of Study area {Vwei (Mararaban Jama'a)–Mangu Road} showing VES Locations.

In the study area, the major structural trends are in N-S, NNE-SSW, NW-SE, and E-W. As shown in Figure 4, several of the linear features cut across the area around failed segments of the highway. At depths  $\geq 5\text{m}$ , geoelectric resistivity soundings interpretation on VES P5, P9, P10, P11, P15, P19 and P20 revealed subsurface structures (Table 1 and Fig. 7).

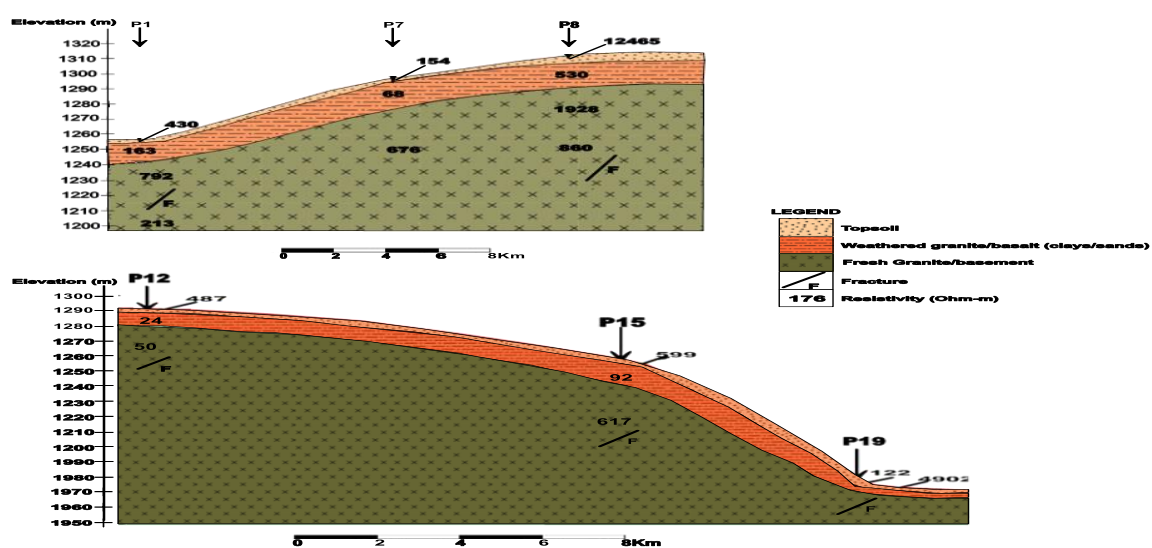
Figures 7 (a) & (b): Geo-electric section along traverse.

This suggests, among other things, two (2) possible scenarios. The first scenario is that the study area is characterized by the occurrence of fresh bedrock at a very shallow depth with fractures at the near surface as observed in the VES P19 (Fig. 7b) can undermine the integrity of the proposed road if not properly handled during construction. Secondly, some parts of the investigated area underlain by weathered layer which are composed of clays can also increase the vulnerability of the road to failure particularly if the depth to the weathered layer is shallow with the evidence of water saturation.

It is suspected that such subsurface structures may be one of the factors responsible for the perpetual failure of the failed segments of the highway especially were they occur at the shallow surface, since linear features are characteristic zones of weakness.

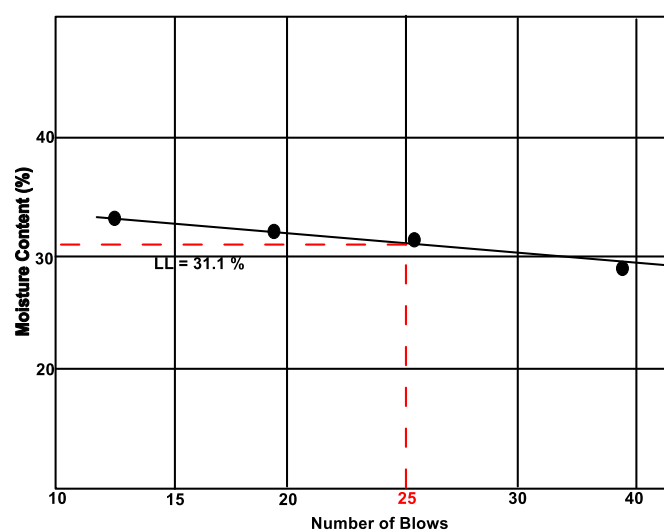
Figure 9: Liquid Limit Graph for Soil Sample taken from Chit Failed Segment

Typical Liquid Limit curve is shown in Figure 9. The Plastic Limit of the soils ranges from 14.40 - 31.60 % for failed segments of the road. The Plasticity Index of soils beneath the failed segments ranges from 11.40 – 18.90 %. Most of the soils (stable and failed localities) investigated fall within the FMWH (1972) specification (Table 3), and are suitable sub-grade materials. Using the America Association of State Highway and Transportation Officials

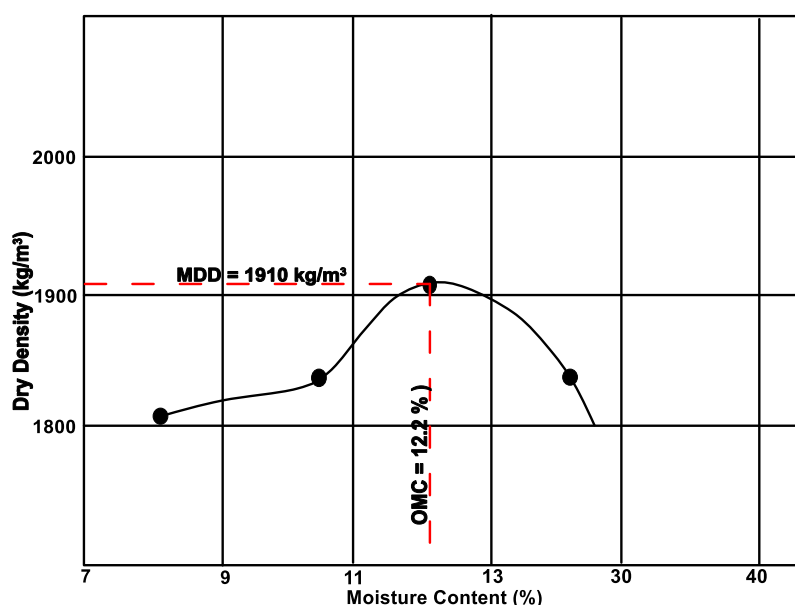
Figure 10: Compaction Curve for Soil Sample Mangu Halle failed Segment

The Optimum Moisture Content (OMC) and the Maximum Dry Density (MDD) obtained from the tested soils are presented in Table 2 while Figure 10 shows typical compaction curve. The Optimum Moisture Content (OMC) ranges from 8.50-14.30 % for soil of the failed segments. The Maximum Dry Density (MDD) ranges from 1795 - 2585 Kg/m for soil of the failed segments.

There is significant overlap between the values of compacted parameters of the soils beneath the failed segments; hence compaction characteristic of the soils may not be a good index for the highway pavement stability.
